Name Of Dam: Motts Run

Location: Spotsylvania County, State of Virginia

Inventory Number: VA 17704

PHASE I INSPECTION REPORT NATIONAL DAM SAFETY PROGRAM

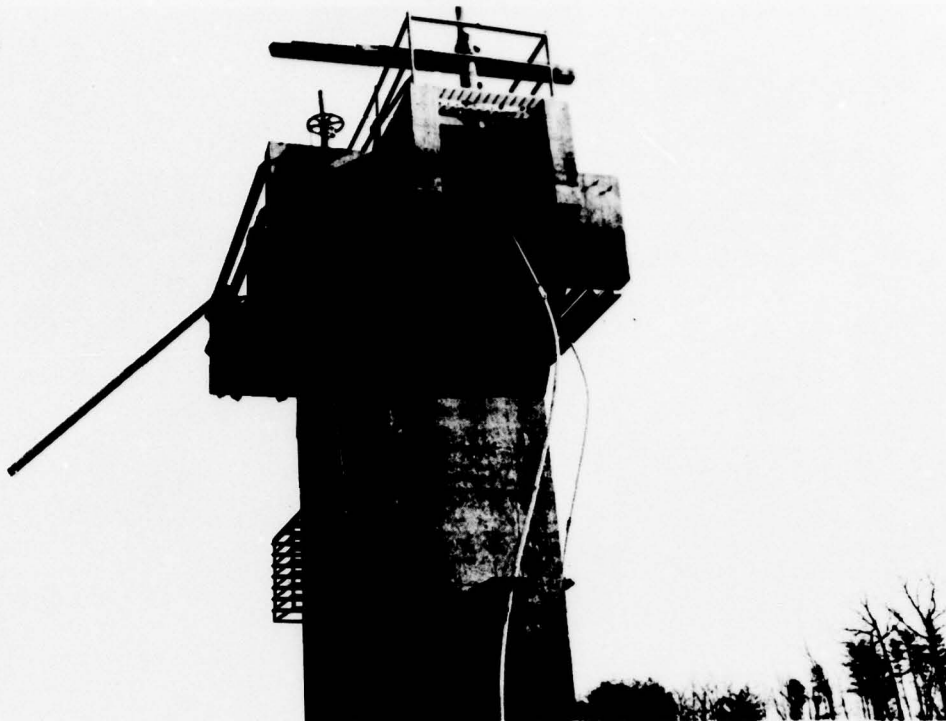
- 3.1.3 Appurtenant Structures: The stems of the water supply gates and pond drain on the riser are severely bent and partially inoperable (see Photo 1). The outlet structure is in good condition and is functioning properly (see Photo 2). The emergency spillway is in satisfactory condition except for a 15 foot deep depression in the approach channel which was part of a natural valley (see Plate 1) before the dam was constructed. Scattered small trees in the emergency spillway should be removed (see Photo 4). Some areas of dried grass on the right slope of the emergency spillway may need to be reseeded.

4.3 Maintenance of Operating Facilities: Maintenance of the water supply gates and reservoir drain are provided by the City of Fredericksburg. All lift stems on the riser are severely bent; consequently, the stems are only partially operable. The stems are apparently bent because of an insufficient number and inadequate placement of stem guides, especially near the top of the riser (see Photo 1).

PHOTO 1. Upstream View of Riser Showing Trash Racks and Bent Gate Stems

- 3.2.2 Appurtenant Structures: The bent stems of the water supply gates and pond drain should be repaired without delay. The deep depression in the emergency spillway approach does not deter proper functioning of the emergency spillway but should be back filled during the dry season. The trees in the emergency spillway should be removed as part of annual maintenance.

4.5 Evaluation: The City of Fredericksburg, at the time of this report, is contracting the work for repairs to the lift stems. This repair work should be completed without delay since the gates in their present condition are not fully operable.

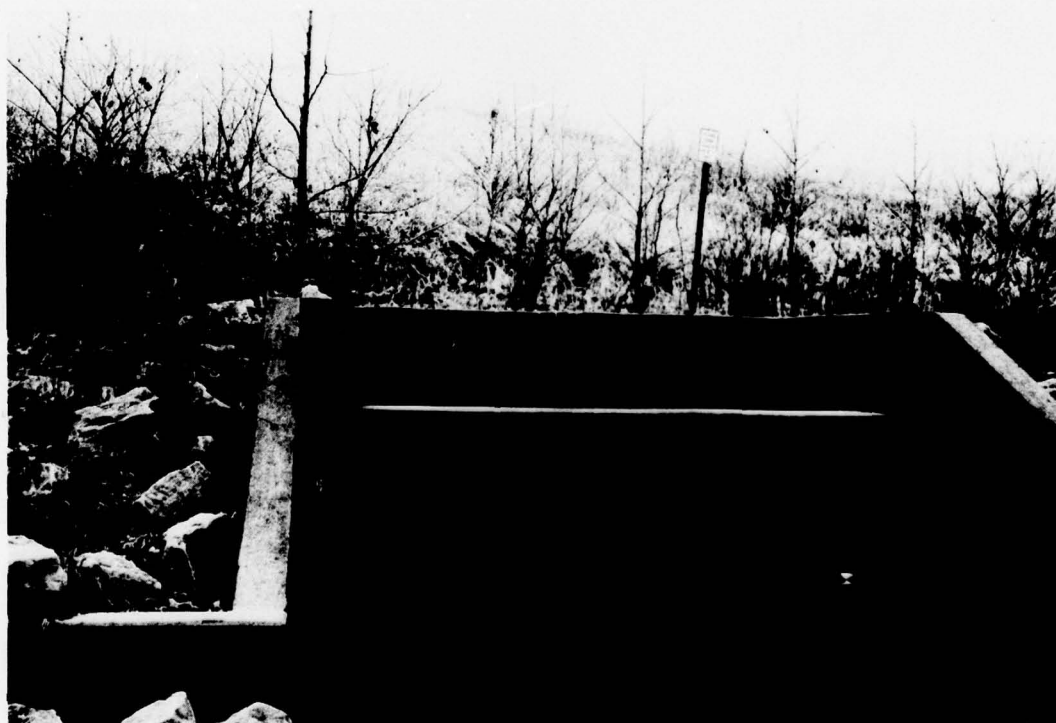
PHOTO 2. Impact Basin, Baffle Wall and Tailwater

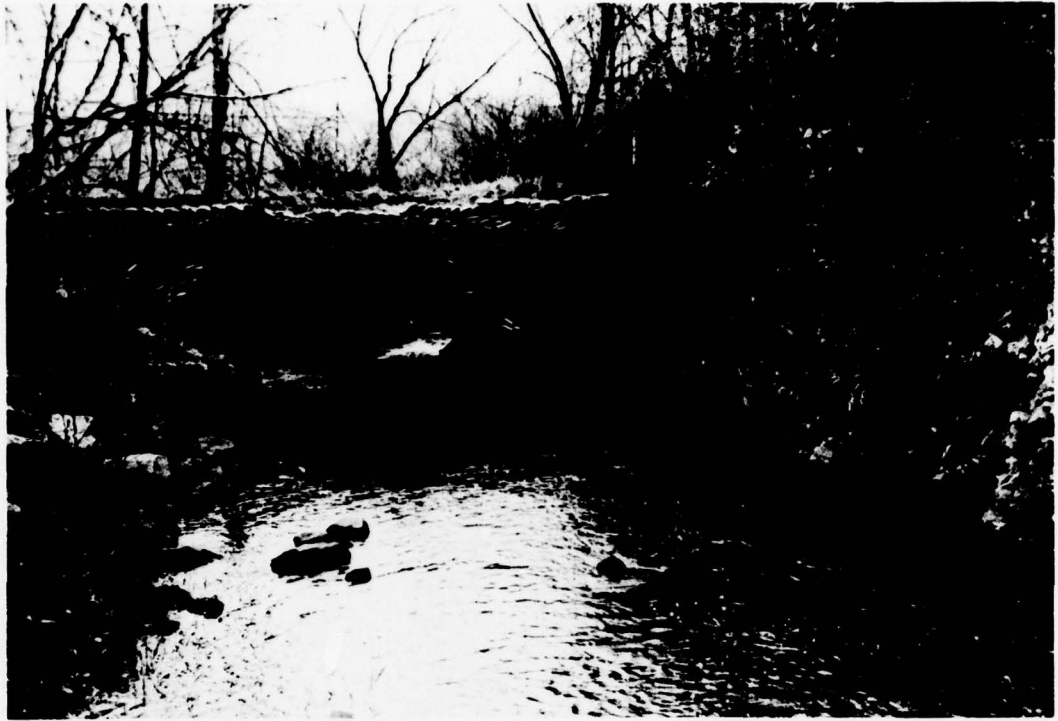
- 3.1.4 Reservoir Area: The slopes in the reservoir above the normal pool elevation are well vegetated with little or no erosion and sloughing. The temporarily exposed soil slopes below the normal pool elevation show evidences of erosion in its early stages. To prevent severe erosion, the reservoir should be refilled as soon as possible after repairs are completed to the riser. Debris was observed along the shoreline of the reservoir.
- 3.1.5 Downstream Channel: The outlet channels for the principal and emergency spillways are in good condition. There are several dead trees and other leaning trees with exposed roots in a thin soil mantle. Some clear seepage and slumping have occurred over bedrock on this steep hillside slope to the right of the impact basin (see Photo 3).

PHOTO 3. River Road Culvert Located Immediately Downstream From Impact Basin

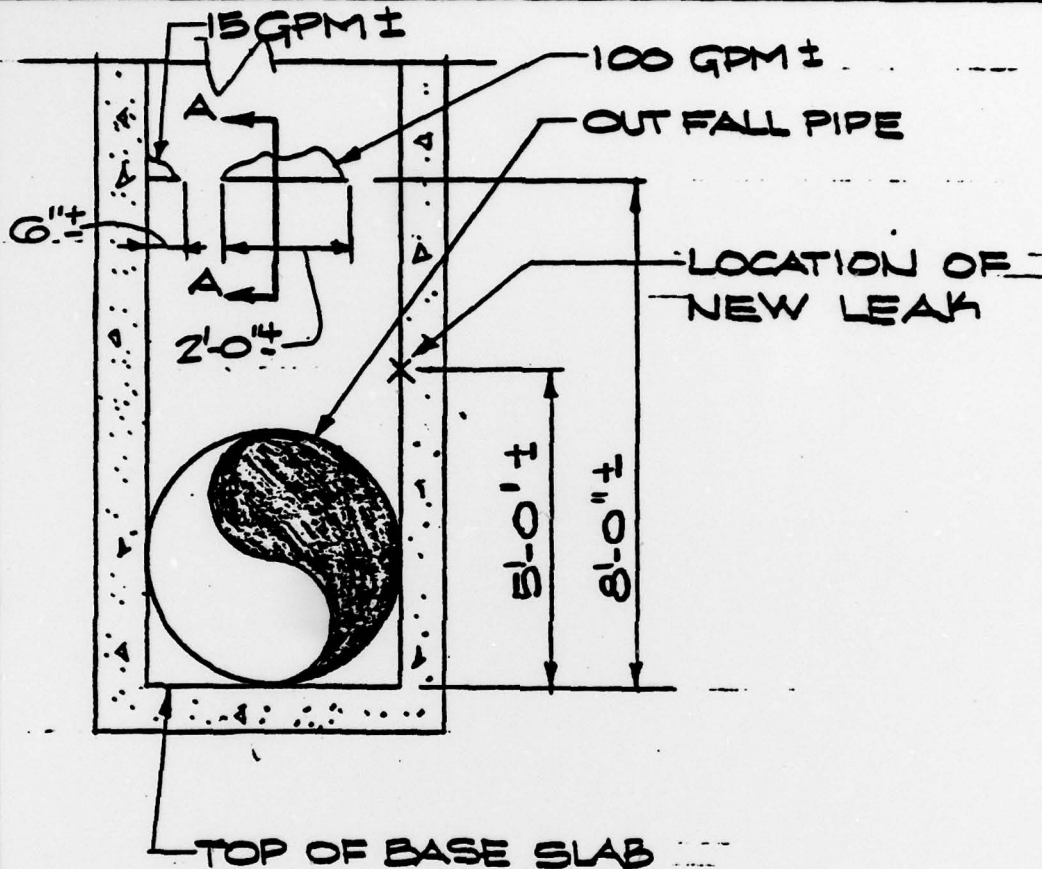
SECTION OF RISER
LOOKING NORTH

Two major leaks were observed at the construction joint between the riser and the transition section to which the outfall pipe is connected. A larger, triangular spalled area, through which there is a flow of approximately 100 gallons per minute, is about two feet long by six inches wide and is centrally located between the east and west walls of the riser. Through a smaller spalled area at the west wall of the riser, about 6 inches long by 6 inches wide, there is a flow of approximately 15 gallons per minute. A third leak at the construction joint was discovered after slime was removed from the east wall. Its flow rate is about one gallon per hour.

Attached hereto are a sketch showing the locations of the leaks and photographs of the exterior and interior of the riser. The photographs of the riser interior show the construction joint at the top of the transition section where the leakage occurs. Encrustations and damaged concrete can be seen.

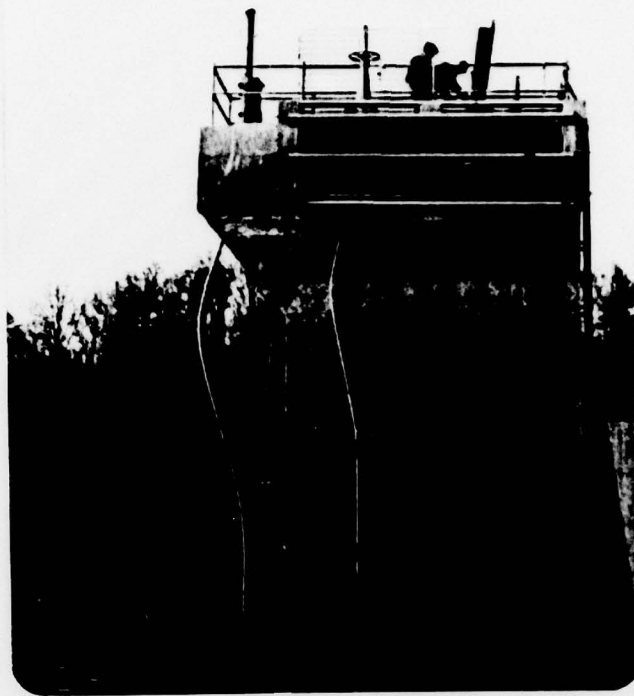
The exterior surface of the upper 25'-0" of the riser appeared to be in good condition. The concrete appeared to be sound and free of cracks and honeycomb. The lower portion (approximately 50'-0") was below the reservoir surface and could not be inspected from the exterior.

EXTERIOR VIEW OF INTAKE TOWER
